# National Transportation Safety Board

## Marine Accident Brief

### Allision of Offshore Supply Vessel *Connor Bordelon* with Unmanned Platform South Timbalier 271A

<b>Accident no.</b>	DCA15LM012
<b>Vessel name</b>	Offshore supply vessel <i>Connor Bordelon</i>
<b>Accident type</b>	Allision
<b>Location</b>	About 5.25 miles* south of Port Fourchon, Louisiana, jetty channel entrance 28°59.9' N, 90°13.75' W
<b>Date</b>	January 23, 2015
<b>Time</b>	0432 central standard time (coordinated universal time – 6 hours)
<b>Injuries</b>	None
<b>Property damage</b>	Between \$350,000 and \$500,000 to the <i>Connor Bordelon</i> , \$4.1 million to the platform and pipelines
<b>Environmental damage</b>	None
<b>Weather</b>	Cloudy skies with passing rain showers, winds from the northeast at 15 to 20 knots, visibility 3 to 5 miles, seas 3 to 5 feet
<b>Waterway information</b>	Gulf of Mexico

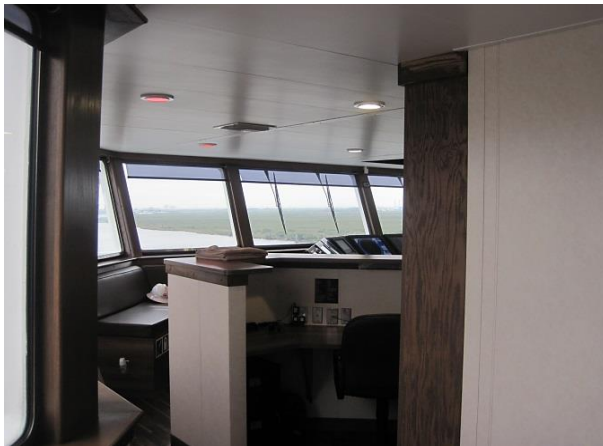
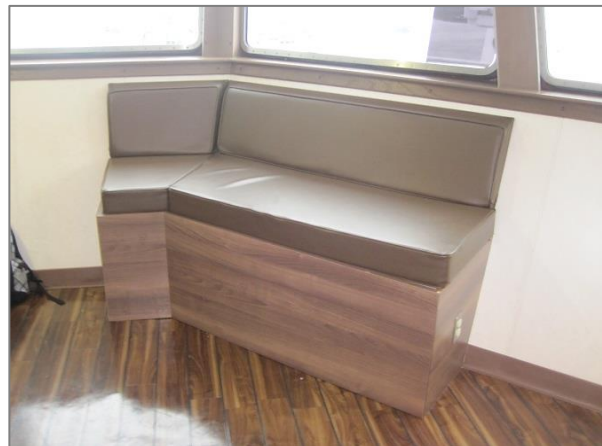
The bridge team on the accident watch consisted of the two mates, an able-bodied (AB) unlicensed sailor qualified to perform routine duties aboard the vessel, and an ordinary seaman (OS) who had less experience than the AB. The AB and the OS performed various duties as directed by the mates, including safety checks of the vessel and, when instructed, lookout duties. The two mates switched out the conn as they deemed appropriate. The mate on watch at the time of the accident took over the conn about 0340, about 50 minutes before the accident. The mate he relieved then went to rest but remained awake on a settee (small couch) located on the starboard side of the bridge below the bridge windows. At that time, the AB was below deck in the galley (with permission from the mate on watch). The OS was on the port side of the bridge in the captain's office, which had a small desk with a privacy wall that would not have allowed a view forward out the windows if he was seated at the desk. According to the AB and the OS, the mate on the settee could perform the lookout duties when called to do so. However, the mate on watch did not ensure that a designated lookout was on the bridge.

The left photo shows the captain's office on the port side of bridge, where the OS was located just before the allision. The right photo shows the settee on the starboard side of the bridge, where a mate was resting just before the allision. (Photos by the Coast Guard)

- **Watchstanding practices:** The officer of the watch needs to ensure that a proper lookout is posted during navigation. In this case, the officer did not designate one of the available watchstanders as the lookout, resulting in a missed opportunity to detect the platform earlier.

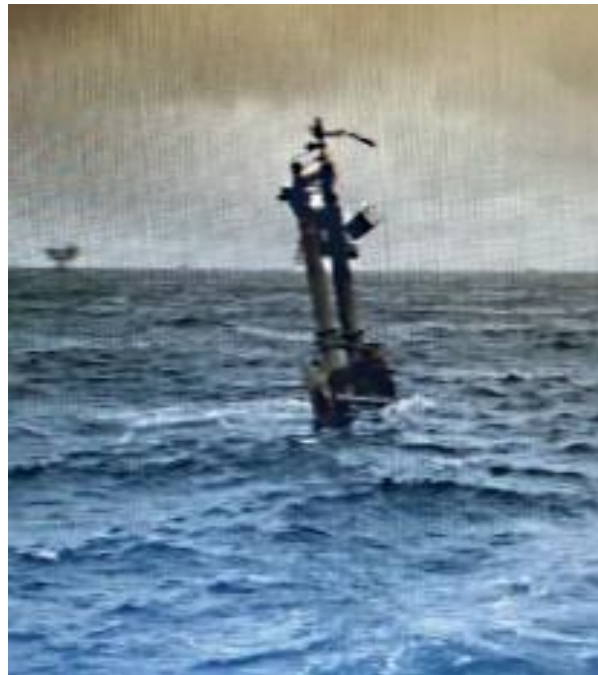
engine rpm but was not able to disengage the autopilot fast enough to maneuver away from the platform. At 0432:00, the video showed the crew on the bridge bracing for an impact and some articles falling off shelves, indicating the point at which the vessel allided with the unmanned platform South Timbalier 271A. The allision occurred at a speed of about 8.7 knots. The allision caused the platform's pipelines to rupture and the released gases to ignite.

The left photo shows the unmanned platform South Timbalier 271A before the accident, and the right photo shows the remains of the platform after the allision and fire. (Photos provided by the Coast Guard)
